March 5, 2009

RE: 14-26 EGMONT STREET AND 15-25 THATCHER STREET, BROOKLINE, MASSACHUSETTS

Subject: Masonry Facade Condition Survey

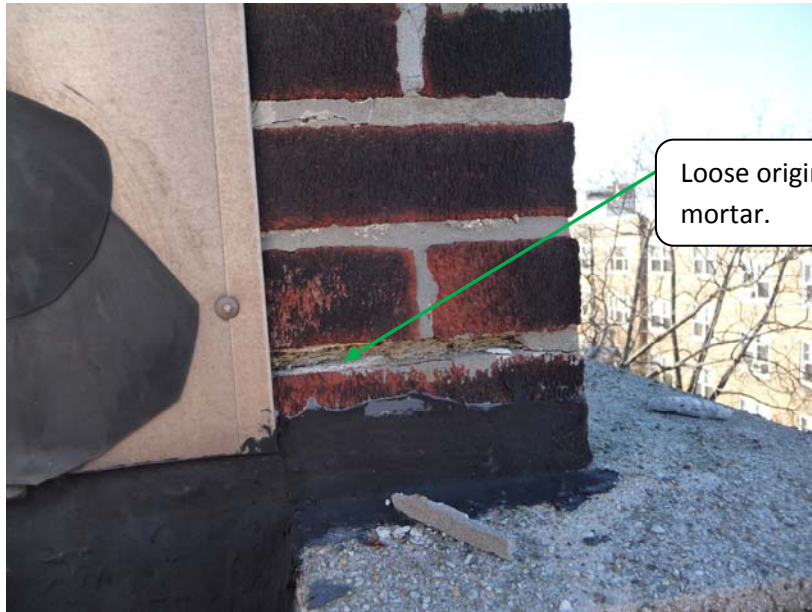
Photograph 1

- The exterior walls are multi-wythe brick masonry bearing walls with a better quality brick on the front façade.
- On the front façades of both buildings we observed the mortar joints on the parapet above the cornice concrete band to be poor condition. We observed loose powdery mortar (Photos 1 and 2). We observed on both buildings that mortar joints in this area of the parapet had been repointed in the past. The repointing was poorly done as the joints were not cut deep enough and the mortar was of high cement content. The repointing mortar is falling out and exposing the soft original mortar (Photos 3 and 4). This condition is typical across the entire length of both buildings.

2. On the front elevation of both buildings, the mortar in the repointed mortar joints at the parapet appears to be hard and contains high cement content and was not cut in deep enough. When the brick expands during heat and moisture gain the surface repointing mortar cracked, loosened and in some case has fallen out. When the repointing mortar falls out, the old soft mortar is exposed and soaks up moisture. The moisture freezes and thaws damaging the mortar joint even further.

5. Remove all ivy from the Egmont building. Ivy areas are shown on the attached Existing Condition plans.
6. Repoint deteriorated mortar joint areas identified on the attached Existing Condition plans (4,600 square feet each building).

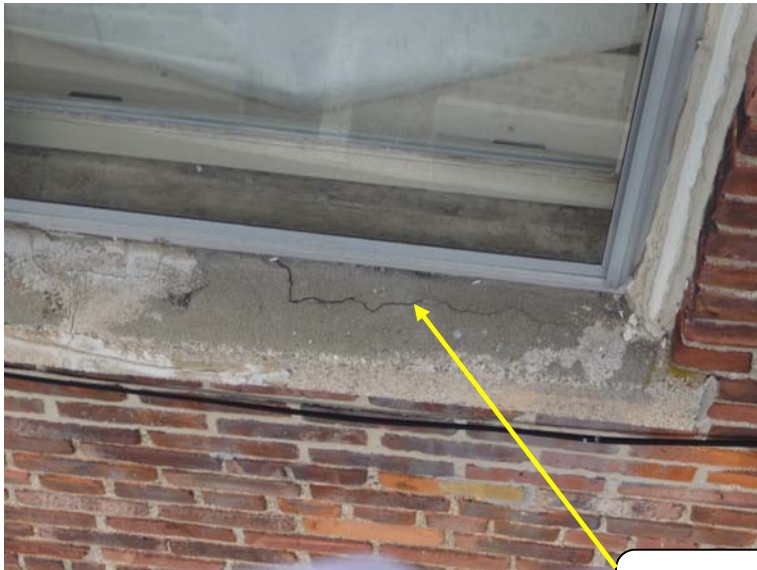
Photograph 5

- We observed several precast concrete sills to be cracked, split and delaminated (Photos 5 and 6). At one location we removed the delaminated concrete to expose the embedded reinforcement bar. The reinforcement bar was corroded (Photo 7).

The cracks and delaminations are the cause of the embedded steel reinforcement corroding. When steel corrodes it will expand up to nine times the original thickness. This expansion of the corrosion product creates internal tension forces within the concrete and will generate enough force to split, delaminate and spall the concrete.

Cracked and split concrete sills.

2. Replace all Delaminated cast concrete sills identified as **DS** on the attached Existing Condition plans (3 single, 1 double and 2 triple for Thatcher Street and 24 single, 1 double and 1 triple for Egmont Street).

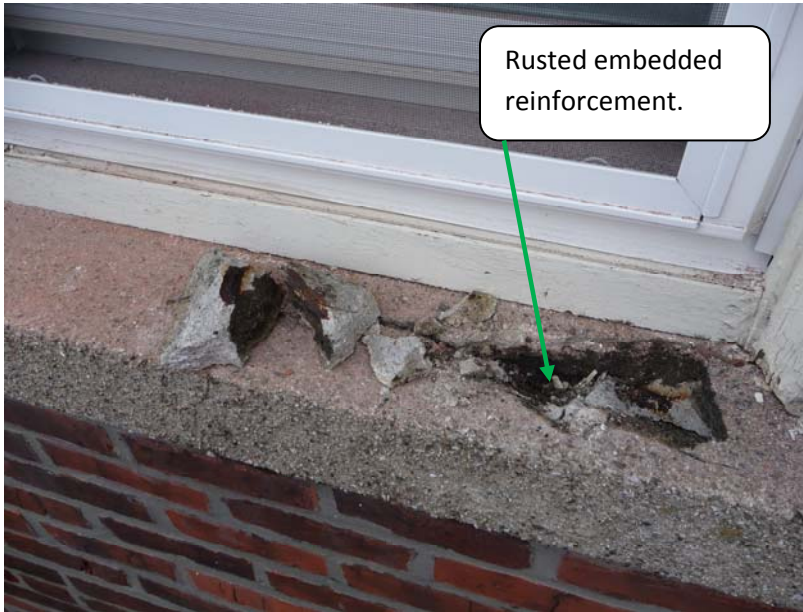
Photograph 7

Rusted embedded reinforcement.

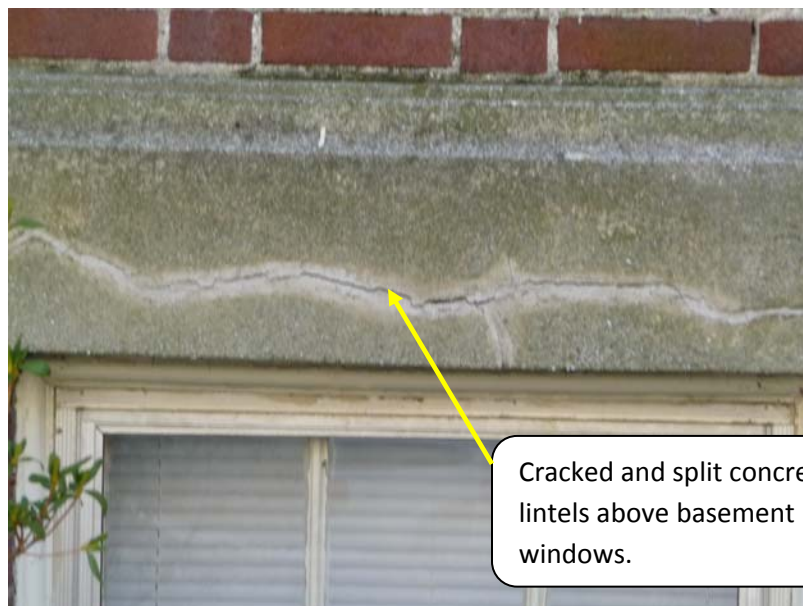
Photograph 8

- We observed several precast concrete lintels at the bands above the basement windows to be cracked, split and delaminated (Photos 8 and 9).
- We observed many of the concrete columns at the front main entryways at both buildings to be cracked, split and delaminated (Photos 10 through 13). At these entryways we also observed that all concrete surfaces had been previously coated. The coating has cracked and failed and debonded (Photos 14 and 15).

Cracked and split concrete lintels above basement windows.

3. Replace the delaminated and cracked precast concrete lintels over the front elevation basement windows (3 at Thatcher Street and 5 at Egmont Street).

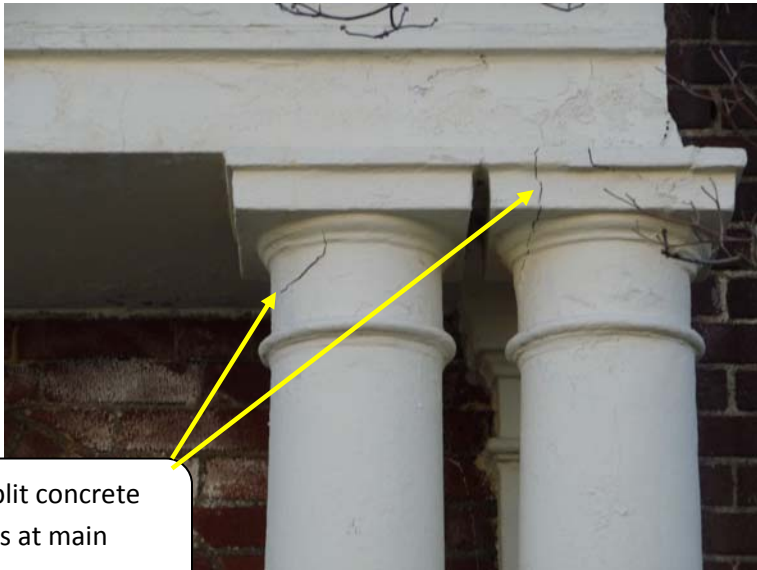
Photograph 11

Cracked and split concrete column capitals at main entryways.

4. Repair the delaminated and cracked concrete columns and decorative elements at the front entryways (40 square feet at Thatcher Street and 175 square feet at Egmont Street). After the repairs are made mechanically removed the existing coating on the entryway concrete elements and recoat with an elastomeric concrete coating.

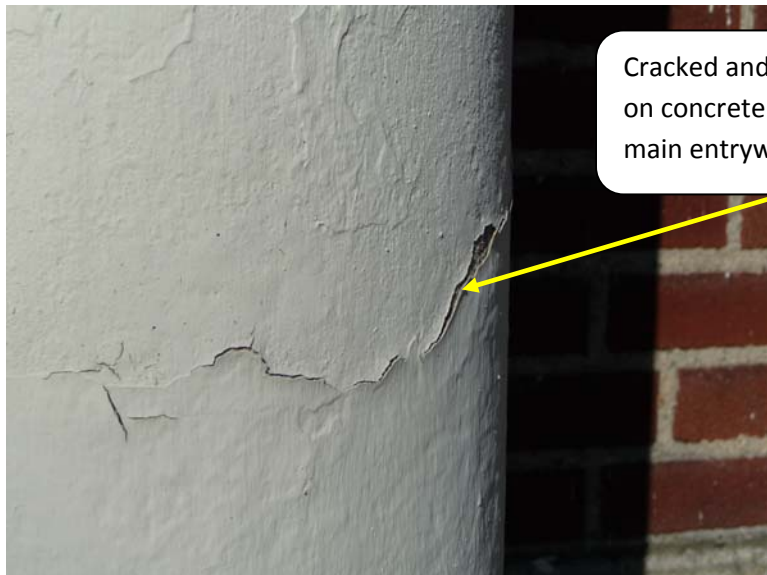
Photograph 14

5. The coating placed on the cast concrete columns and concrete surface at the entryways, as well as the cast concrete medallions above the first floor triple window is brittle, cracked and peeling at most locations. It appears the wrong concrete coating product may have been specified.

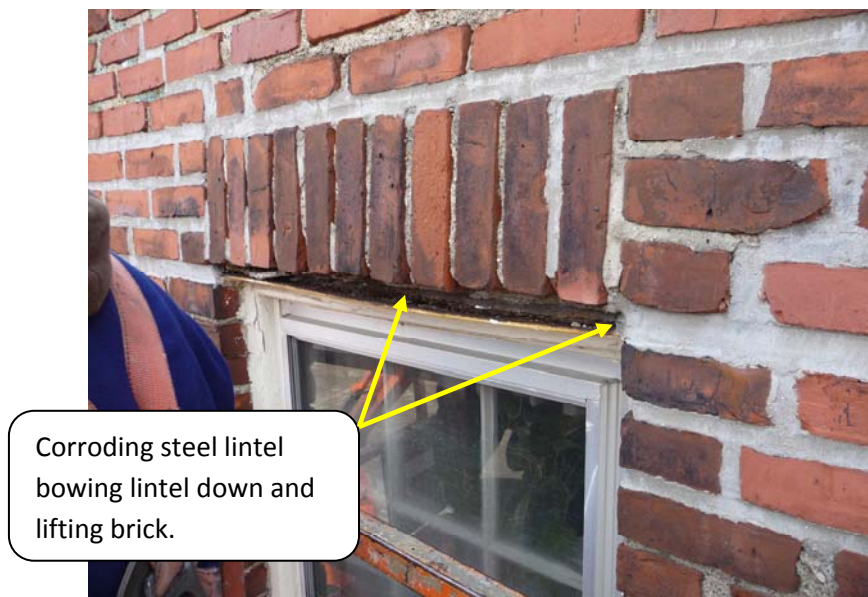
Photograph 16

- The condition of the steel window head lintels at all elevations at both buildings, we observed to be slightly corroded to severely corroded. The most severely rusted lintels where the lintels above the top floor windows on the rear of both buildings with the most of this type observed on the rear of the Thatcher Street building. We observed the brick to be bowing outward and lifted upward as well as the lintel bowed downward caused by the rust expansion (Photos 16 through 19). We removed the brick header course above three top floor windows on the Thatcher Street

4. The damage to the brick around the window head and the bowing of the steel lintels are caused by moisture penetrating through the exterior brick and corroding the steel lintel. The moisture is also trapped by the sealant or mortar placed in the joint between the steel lintel toe and the header brick. When steel corrodes it will expand up to nine times the original thickness. This expansion of the corrosion product creates enough force to lift up and bulge the brick and push down the lintel. At one location we observed up to an inch and a half of rust product.

1. Replace all rusted lintels identified as **RL** on the attached Existing Condition plans (78 single for Thatcher Street and 26 single, 13 double and 5 triple for Egmont Street). To replace the lintel the header brick course will be removed, the inside wythe of brick will be parged, a new galvanized lintel installed, through wall head flashing installed and the brick header replaced.

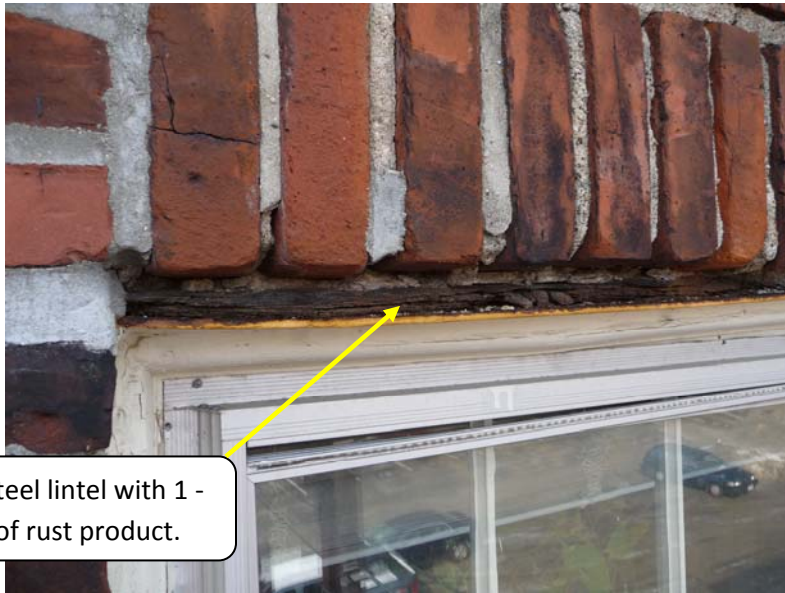
Photograph 19

Corroded steel lintel with 1 - 1/2 inches of rust product.

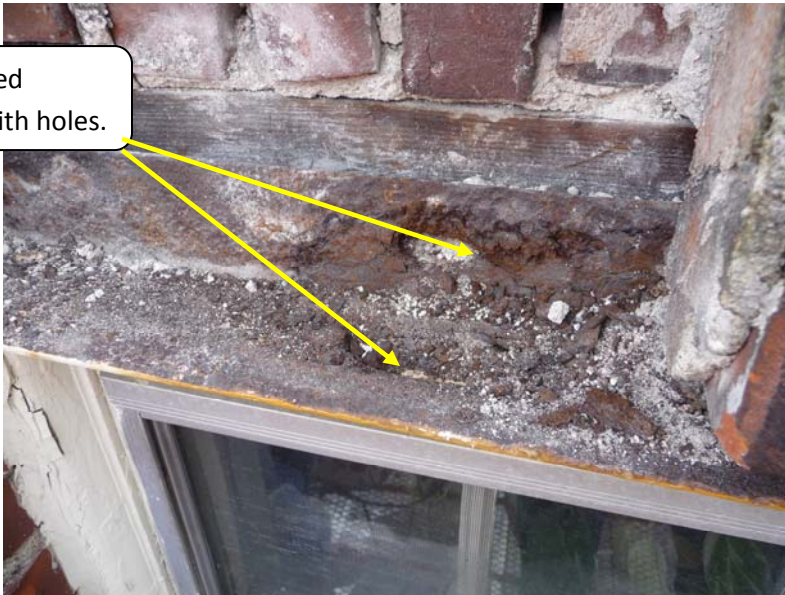
Photograph 20

building to observe the lintel and the as built construction. The lintels at the three locations were corroded and at one location the steel was completely gone and a finger could be pushed through the lintel creating a hole (Photos 20 and 21).

Lintel rusted through with holes.

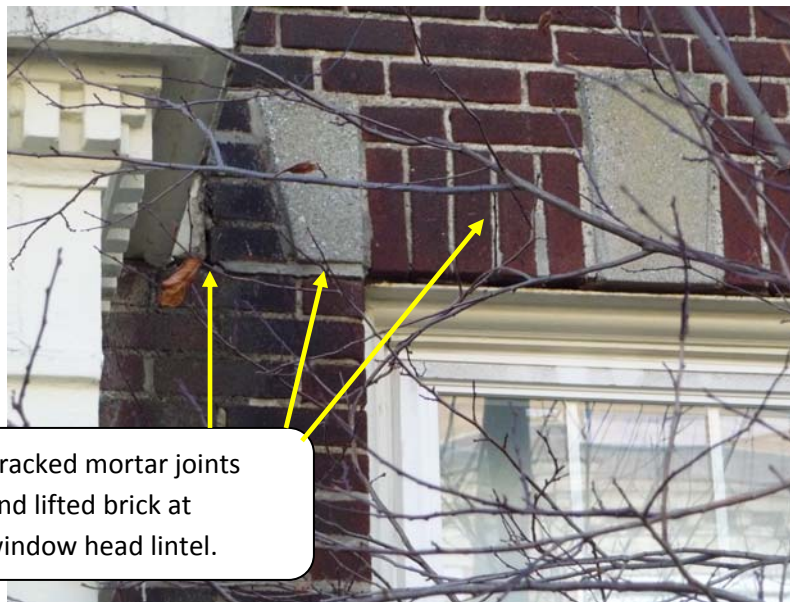
Photograph 22

- The front façade steel lintels across the double and triple windows varied in condition. We observed most with slight rust but observed some with evidence of more corrosion by observance of cracked mortar joint and lifted brick at the lintel head corners (Photos 22 and 23). The front façade Thatcher Street building lintels were in better condition than the Egmont Street building.

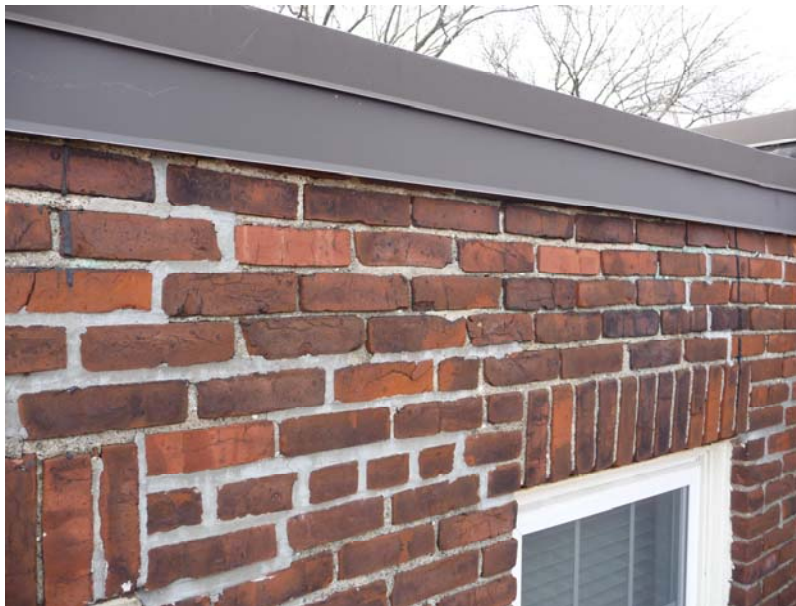
Photograph 24

- We observed the condition of the mortar joints on all elevations of both buildings. On the rear and side elevations of both buildings we observed the majority of the joints to be weathered but sound. We did observe areas of severely weather washed out and soft joints that we would consider in need of repointing. These areas are primarily near the top of the walls above the third floor windows and at the base of the walls near the splash zone (Photo 24 and 25). All areas that we consider in need of repointing are identified on the attached drawings.

1. On the rear of both building the mortar joints are weathered for over 80 years of service, however, the mortar is sound for the majority of the surface area. We observe areas of spot repointing done in the past. We did observe areas of soft and washed out mortar in need of repointing. These areas are primarily along the top floor window to roof line and in the splash zones at the base of the walls. The areas in need of repointing represent approximately 25 percent of the rear and side wall areas.

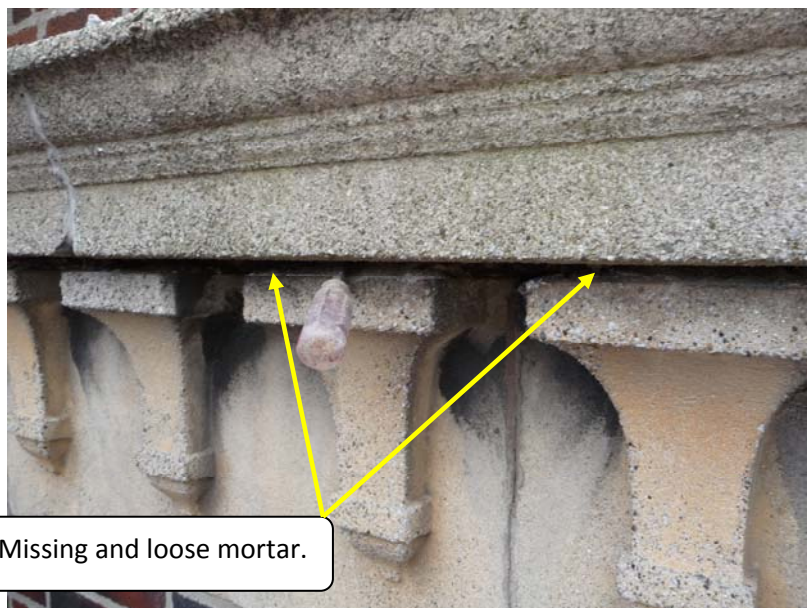
Photograph 26

- The joint between the top front precast concrete cornice band and the precast concrete decorative bracket has missing and loose mortar (Photo 26). This condition is typical across the front of both buildings.

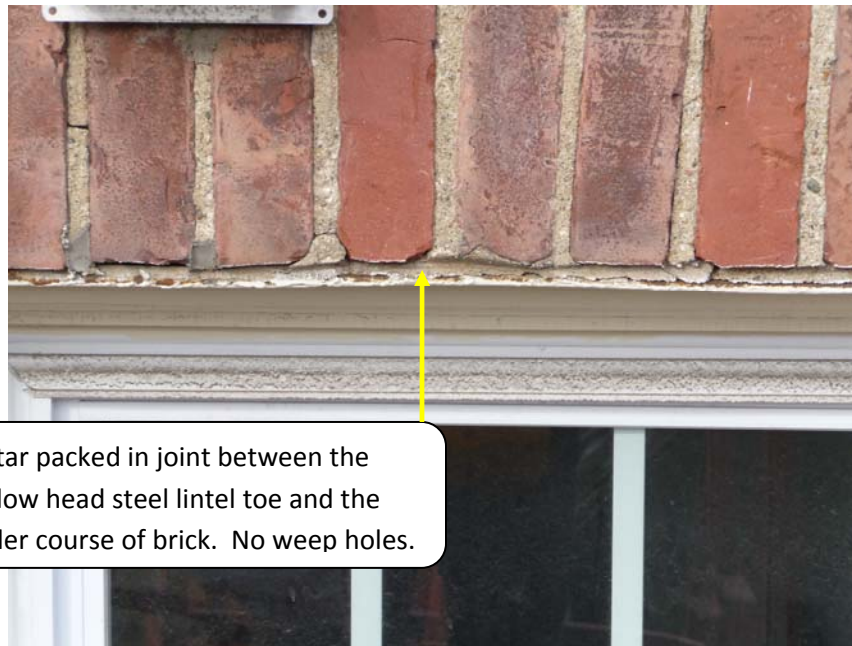
Photograph 27

- We observed many locations where the horizontal joint between the steel lintel and brick contains sealant (Photo 27) or mortar. No weep holes were observed.

Mortar packed in joint between the window head steel lintel toe and the header course of brick. No weep holes.

7. To allow moisture to drain out from the window lintel, remove the existing mortar and/or sealant from the joint between the brick header course and the window steel lintel toe at all windows on both buildings.
