ROOF INSPECTION REPORT

**THATCHMONT CONDOMINIUM
BROOKLINE, MASSACHUSETTS**

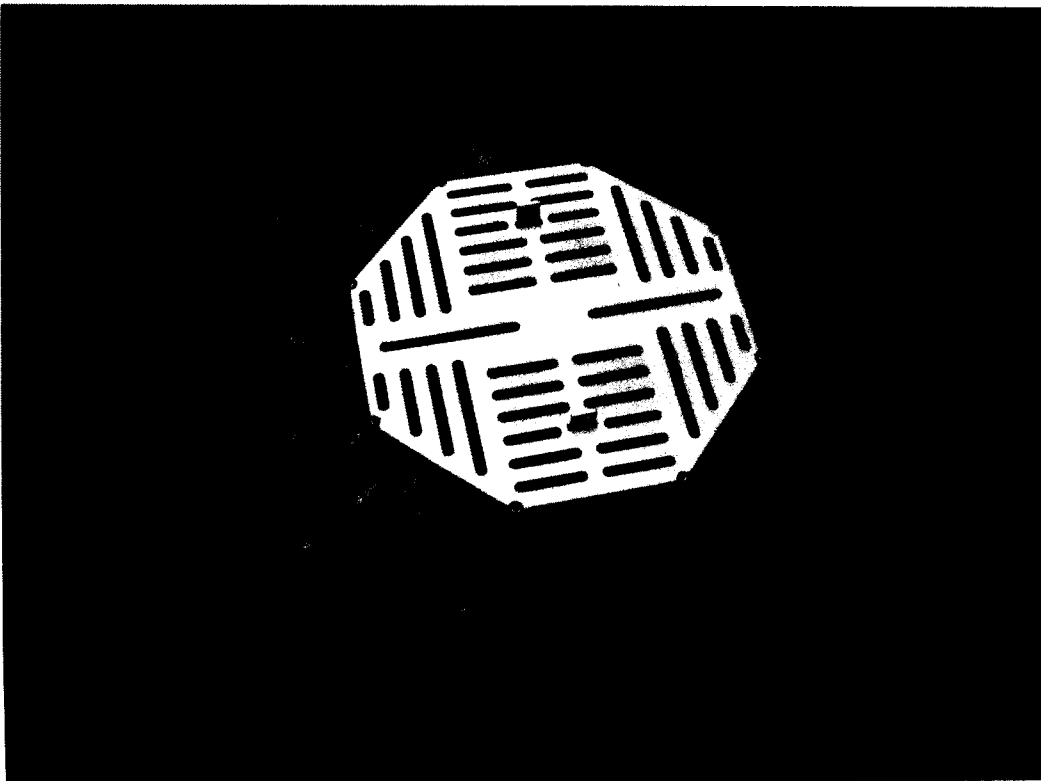
The accumulation of leaves and acorns is a concern for all the roof sections on the Thatcher Street building, but at #15 we observed a significant blockage of the roof drain that was causing a large area of ponded water. This is an adverse condition for an EPDM roof system.

15 THATCHER STREET ROOF DRAIN BLOCKED WITH LEAVES AND ACORNS
